Manhole Inspection Summary

Manhole # S49A__027MH

Insp Date: **6/11/08 8:03 AM**

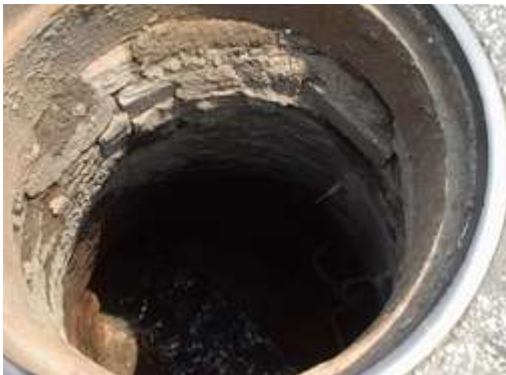
Defect 1

Frame Offset: **4** (in.) Condition: ☐ Sound ☐ Cracked ☒ **Leaks**

Offset frame, frame leaks

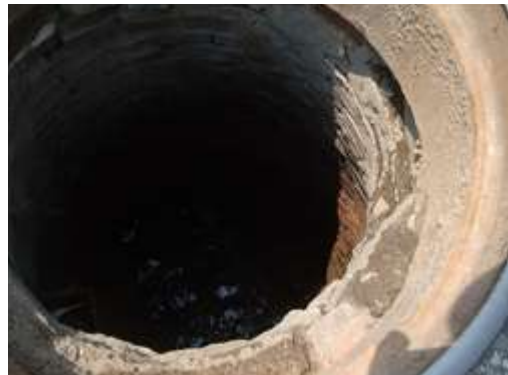
Defect 2

Condition: ☐ Sound ☐ Cracked ☐ Root Intrusion ☒ **Loose Brick** ☐ Deteriorated

Infiltration: ☐ None ☐ Joint ☐ Cracks ☒ **Mortar** ☐ Roots ☐ Wall

loose bricks

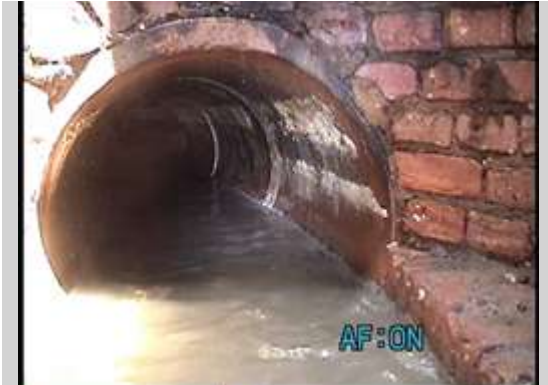
12 O'Clock Outflow

21 in. Circular Gravity Sewer
Pipe Out @ 12 O'Clock

Pipe Height: **21.6** (in.) Rod and Bar (Angled)
Pipe Material: **Clay** ☐ Pipe Lined
Invert Depth: **9.70** (ft.) Flow Characteristics: **Fast**
Deposits: ☒ None ☐ Mud ☐ Sludge ☐ Debris ☐ Grease
Silt Depth: (in.) Deposits Extent:
Infiltration: **None** Pipe Seal Cond: **Sound**

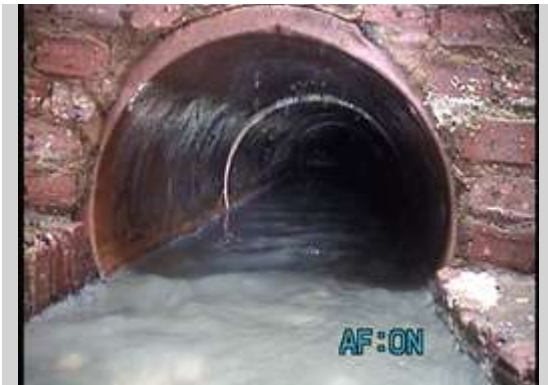
7 O'Clock Inflow

21 in. Circular Gravity Sewer
Pipe In @ 7 O'Clock

Pipe Height: **21.6** (in.) Rod and Bar (Angled)
Pipe Material: **Clay** ☐ Pipe Lined
Invert Depth: **9.60** (ft.) Flow Characteristics: **Fast**
Deposits: ☒ None ☐ Mud ☐ Sludge ☐ Debris ☐ Grease
Silt Depth: (in.) Deposits Extent:
Infiltration: **None** Pipe Seal Cond: **Sound**
